#### Preface

Progressive AE. 2015. Diamond Lake: A Resource and Guidebook for Homeowners

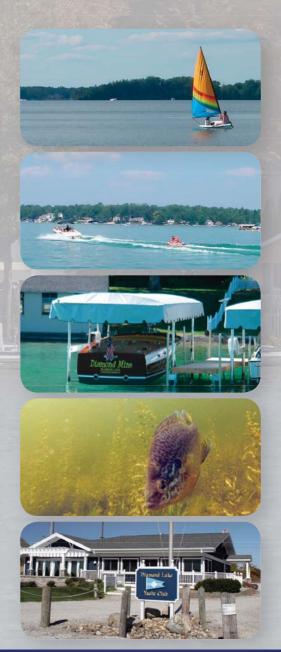
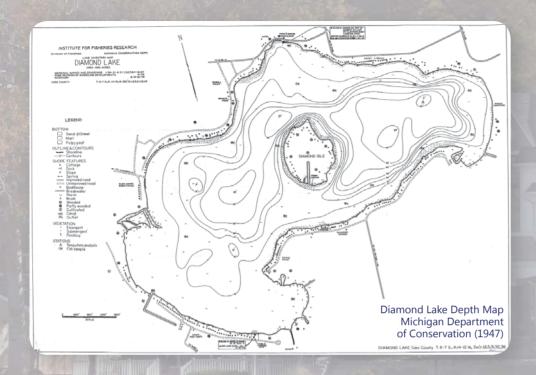
#### **Diamond Lake Physical Characteristics**

Lake Surface Area:	1,044 Acres
Maximum Depth:	64 Feet
Mean (Average) Depth:	16.4 Feet
Lake Volume:	.17,133 Acre-Feet
Shoreline Length:	8.8 Miles
Shoreline Development Fact	tor:1.9
Lake Elevation:	852.25 Feet

Diamond Lake is located partially within the townships of La Grange, Penn, Jefferson and Calvin. The lake bottom was first mapped by the Michigan Department of Conservation in 1947. At that time, lake mapping was conducted during the winter months, with holes drilled through the ice and water depths measured with weighted drop lines. The original map shows gravel shoals around much of the lake and modest development along the shoreline. Over the years, several small canals were constructed along the shore of Diamond Lake, and the south end of the lake was dredged in the late 1960s to create Sail and Diamond View Bays.

With a surface area of 1,044 acres, Diamond Lake is the largest lake in Cass County, and the 94th largest lake in Michigan. The lake has a maximum depth of 64 feet and a mean or average depth of about 16 feet. Diamond Lake contains 17,133 acre-feet of water, which equates to about 5.6 billion gallons. The volume of water in Diamond Lake would cover 27 square miles to a depth of 1 foot.

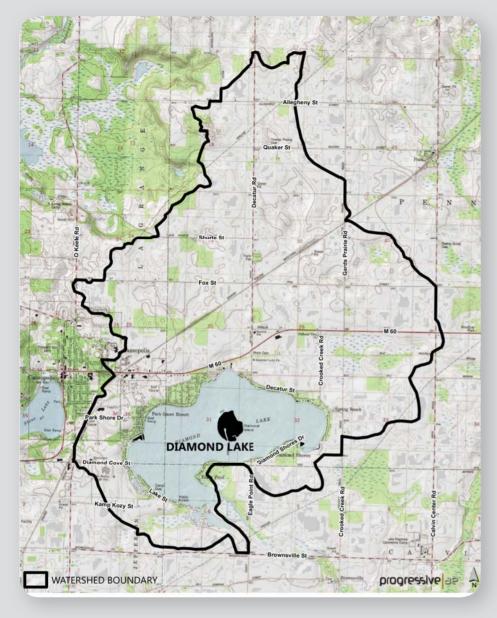
A watershed boundary can be determined by examining a topographic map that shows the "lay of the land" around the lake.

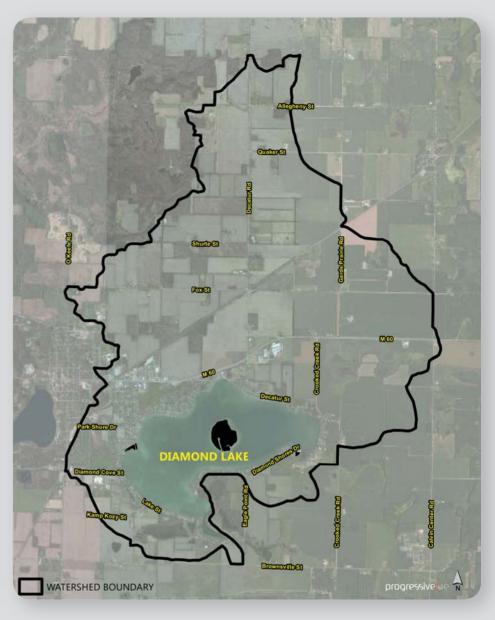
Most of the development in the watershed is concentrated around Diamond Lake.

With an area of 6,828 acres, the Diamond Lake watershed is 6.5 times larger than the lake itself. Much of the upper portion of the watershed (north of M-60) is agricultural land. Fortunately, the soils in the Diamond Lake watershed are primarily well-drained sands and loams and there is little direct drainage from the farmlands in the watershed to Diamond Lake. Most of the development in the watershed is concentrated around Diamond Lake. These urbanized lands adjacent to the lake have a much greater potential to influence water quality.

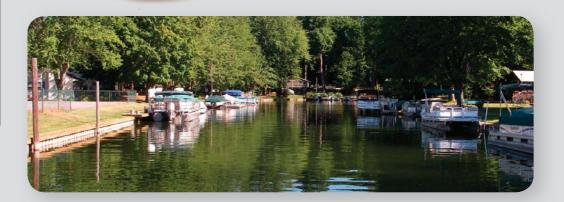
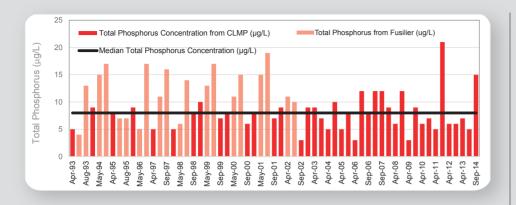
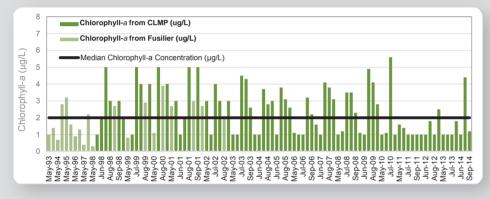
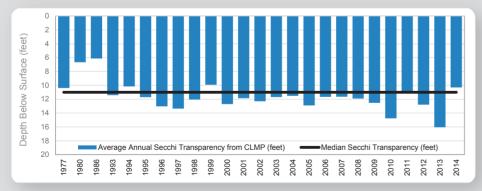
Key parameters used to classify lakes and to evaluate water quality include total phosphorus, chlorophyll-*a*, and Secchi transparency. Data collected from Diamond Lake over the past 20-plus years are summarized in the bar graphs to the left.

Phosphorus is the nutrient that most often stimulates excessive growth of aquatic plants and causes premature lake aging. By measuring phosphorus levels, it is possible to gauge the overall health of a lake. Lakes with a phosphorus concentration of 20 parts per billion or greater are considered to be eutrophic or nutrient-enriched. The median phosphorus concentration of all samples collected from Diamond Lake is 8 parts per billion.

Chlorophyll-a is a pigment that imparts the green color to plants and algae. A rough estimate of the quantity of algae present in the water column can be made by measuring the amount of chlorophyll-a in the water column. A chlorophyll-a concentration greater than 6 parts per billion is considered characteristic of a eutrophic condition. The median chlorophyll-a concentration of all samples collected from Diamond Lake is 2 parts per billion.

A Secchi disk is a round, black and white, 8-inch disk that is used to estimate water clarity. Eutrophic lakes have a Secchi transparency of less than 7.5 feet. Generally, it has been found that plants can grow to a depth of about twice the Secchi disk transparency. The median of all Secchi transparency readings taken in Diamond Lake is 11 feet.

Sampling to date indicates that Diamond Lake is a high quality, mesotrophic lake. Total phosphorus and chlorophyll-a levels are generally low and Secchi transparency is good. The water quality in Diamond Lake provides excellent habitat for
